Conext Three Phase Inverters

How to upgrade the Comm and DSP
firmware

2014-06-22

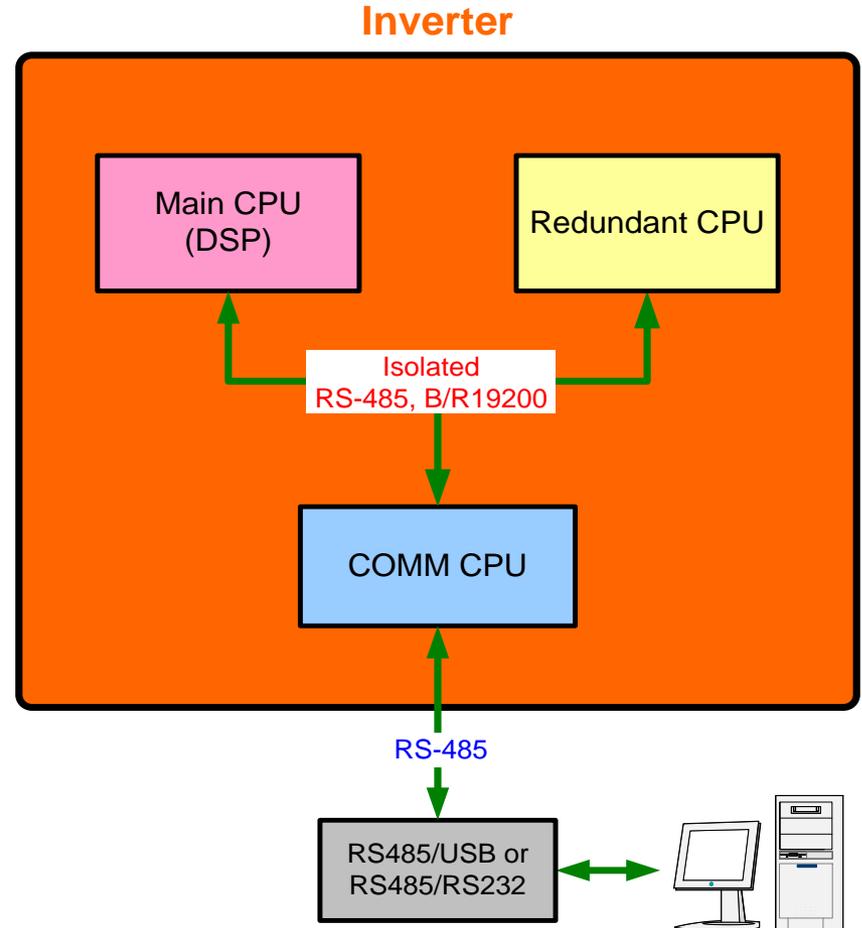
- There are 3 CPUs inside the inverter
- Upgrade DSP or Red., the data must go through the COMM CPU
- Upgrade B/R is fixed at 9600

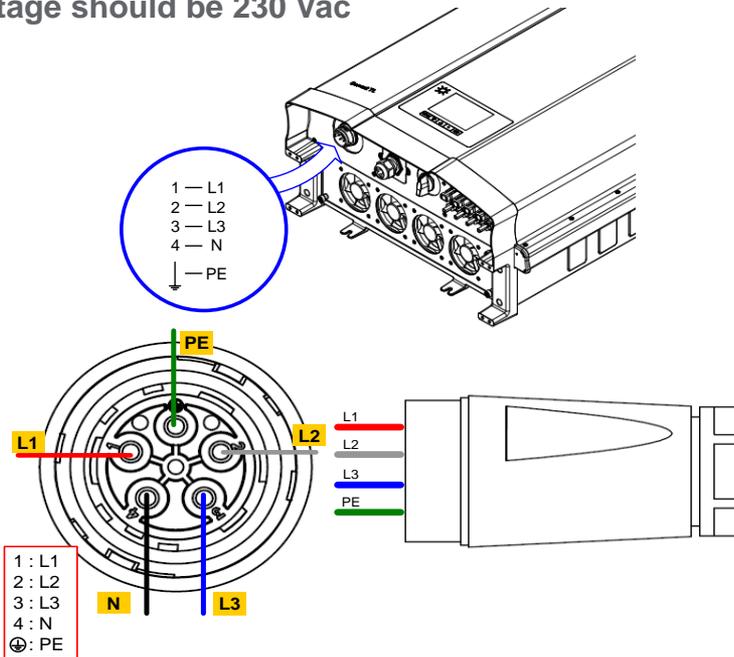
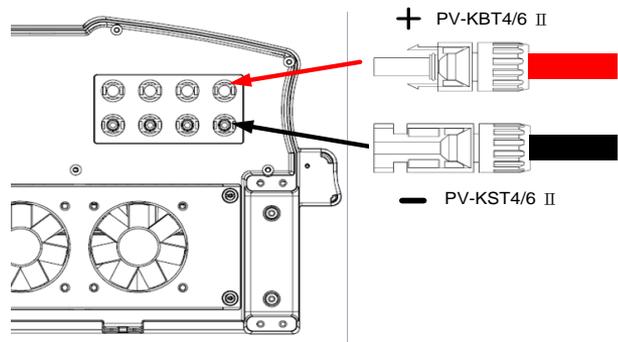
Either DC or AC. Only one is required

DC Input voltage should be > 200 Vdc

AC voltage should be 230 Vac

Either
One

> 200Vdc

1. Keep switch off before connect to inverter
2. Beware of the connection that L1 to pin1, L2 to pin2, L3 to pin3, and PE to Ground.
3. **Incorrect wiring of PE (ex. PE and L1 were reversed) will cause electric shock or damage computer and/or inverter**
4. **Don't connect both DC and AC power, or inverter will start to operate**

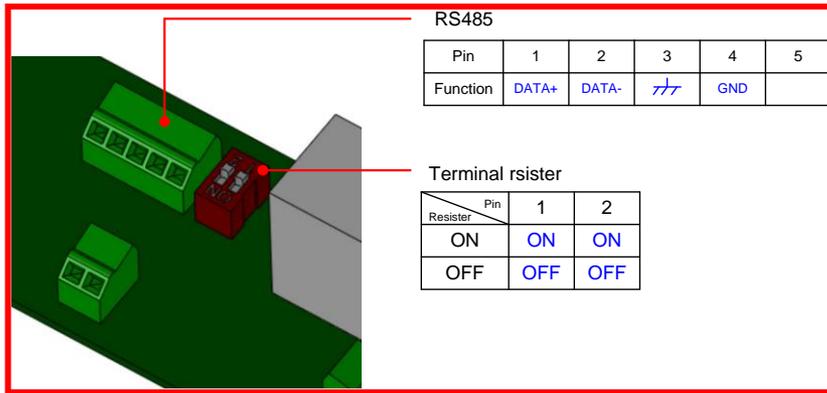
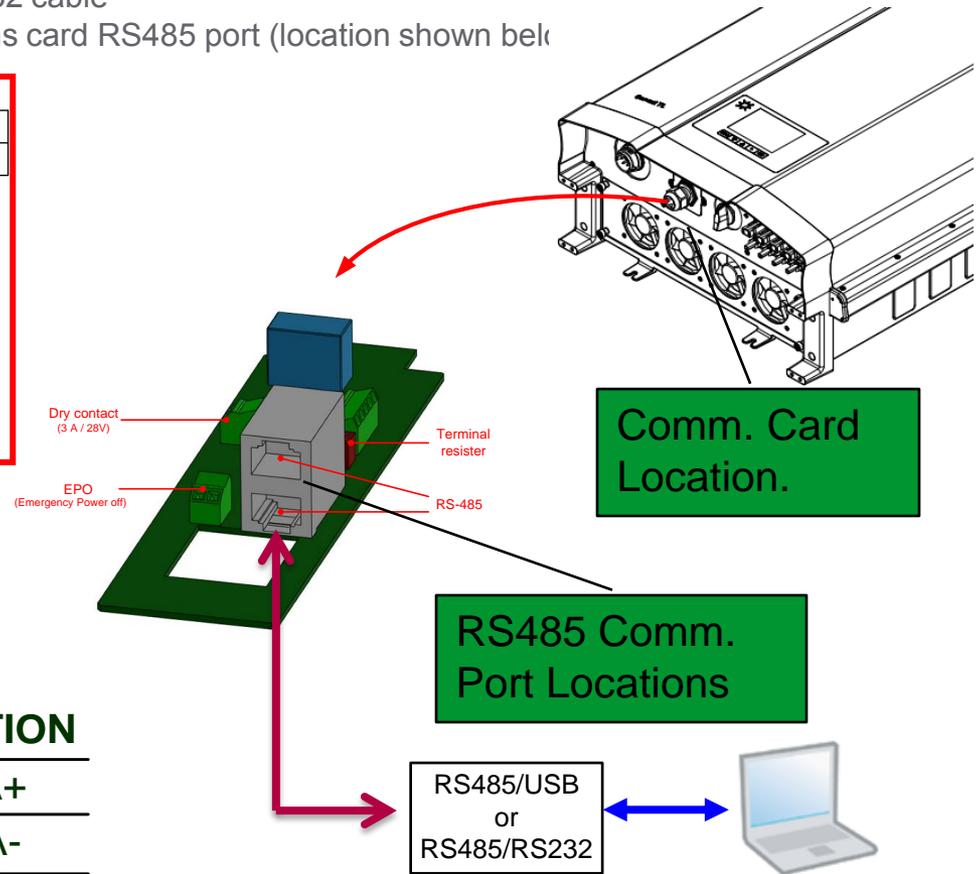
- Loosen 2 screws and remove cover plate to access comm. card. (location shown below)
- Connect computer to RS485/USB or RS485/RS232 cable
- Connect RS485 port from cable to communications card RS485 port (location shown below)

PIN	FUNCTION
4	DATA+
5	DATA-
8	GND

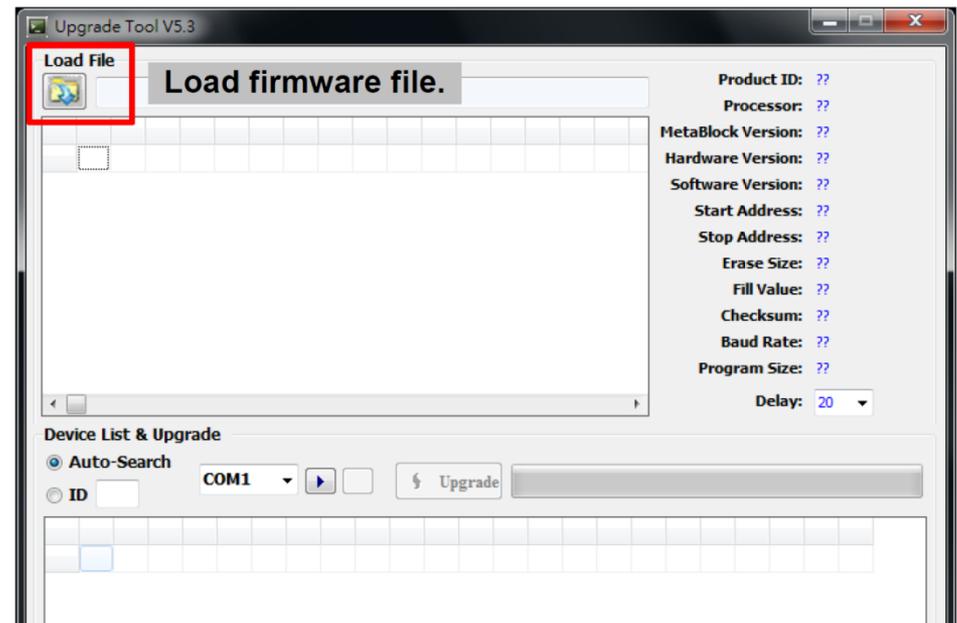
- I. Download the firmware files from SolarExchange (Services/Conext TL/Firmware)
- II. Execute the program “Upgrade V5.3.exe”
- III. Click Load File and select the correct firmware file. It is suggested to start with COMM firmware first.

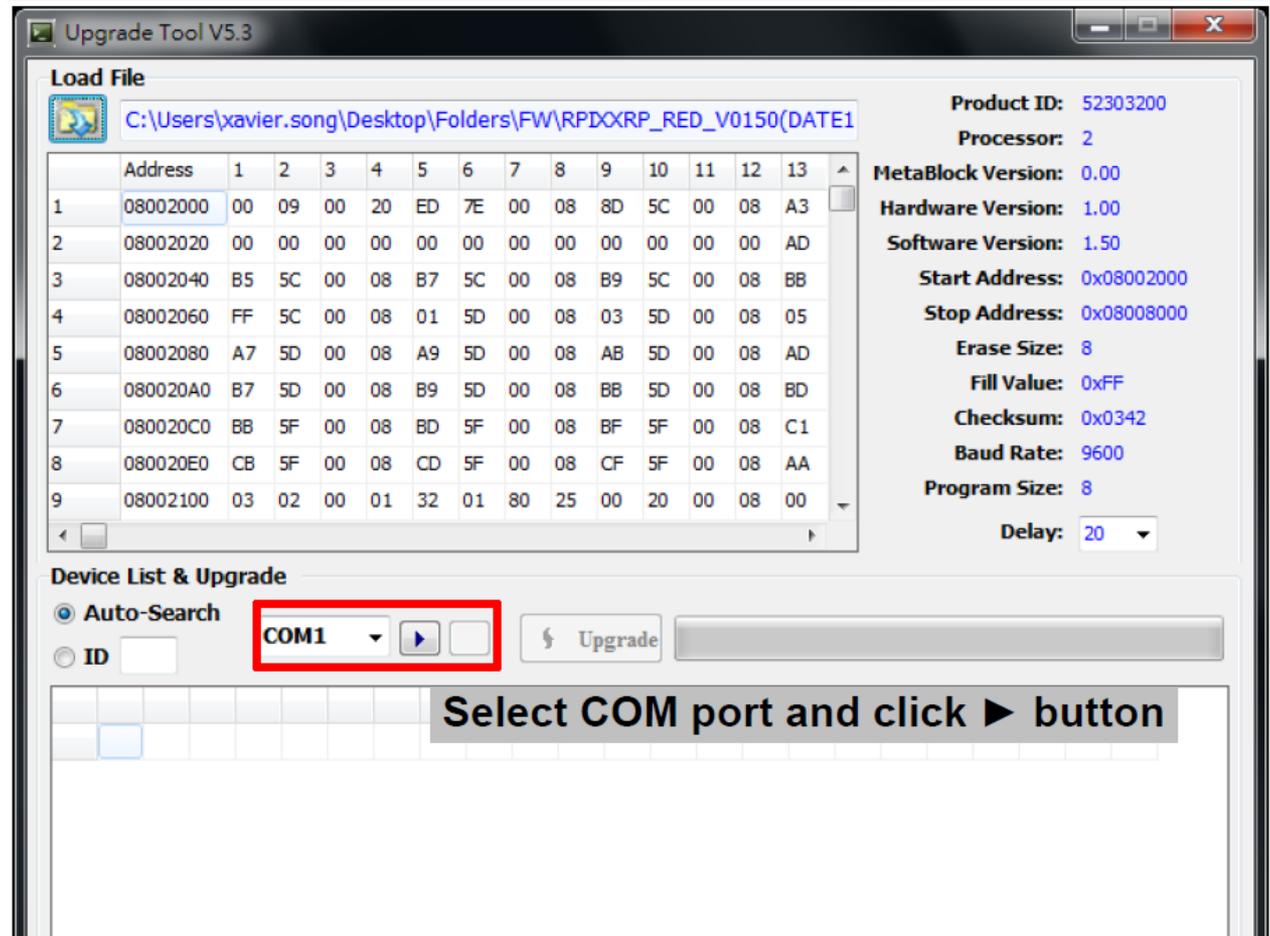
IV. Select the correct COM port and press the Arrow button.

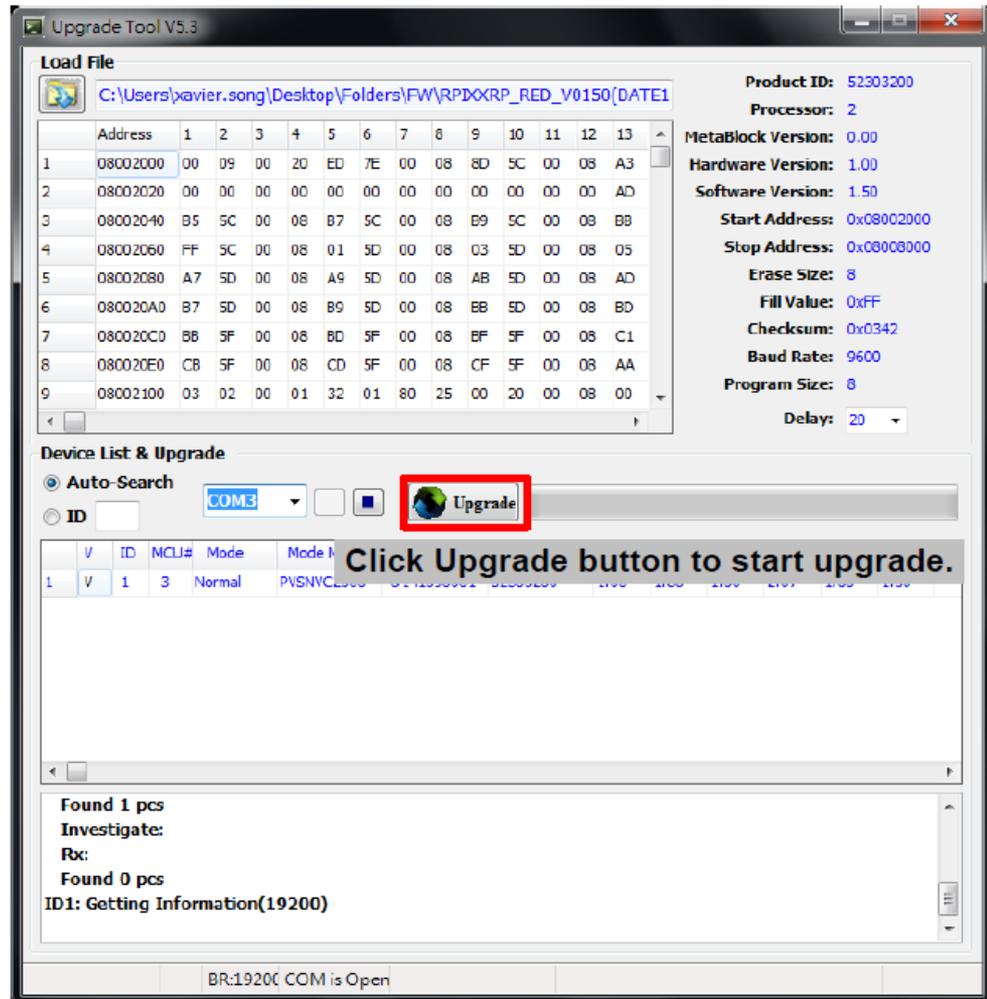
V. Check the current firmware version before uploading.

The screenshot shows the 'Upgrade Tool V5.3' interface. The 'Load File' section displays a file path: `C:\Users\xavier.song\Desktop\Folders\FW\RPDXRP_RED_V0150(DATE1`. The 'Device List & Upgrade' section is set to 'Auto-Search' with 'COM3' selected. A table below lists device details for a single device.

Red boxes highlight the 'P0 SW', 'P1 SW', and 'P2 SW' columns in the table. Red arrows point from these boxes to labels below: 'Comm. Version' (pointing to P0 SW), 'DSP Version' (pointing to P1 SW), and 'Red. Version' (pointing to P2 SW).

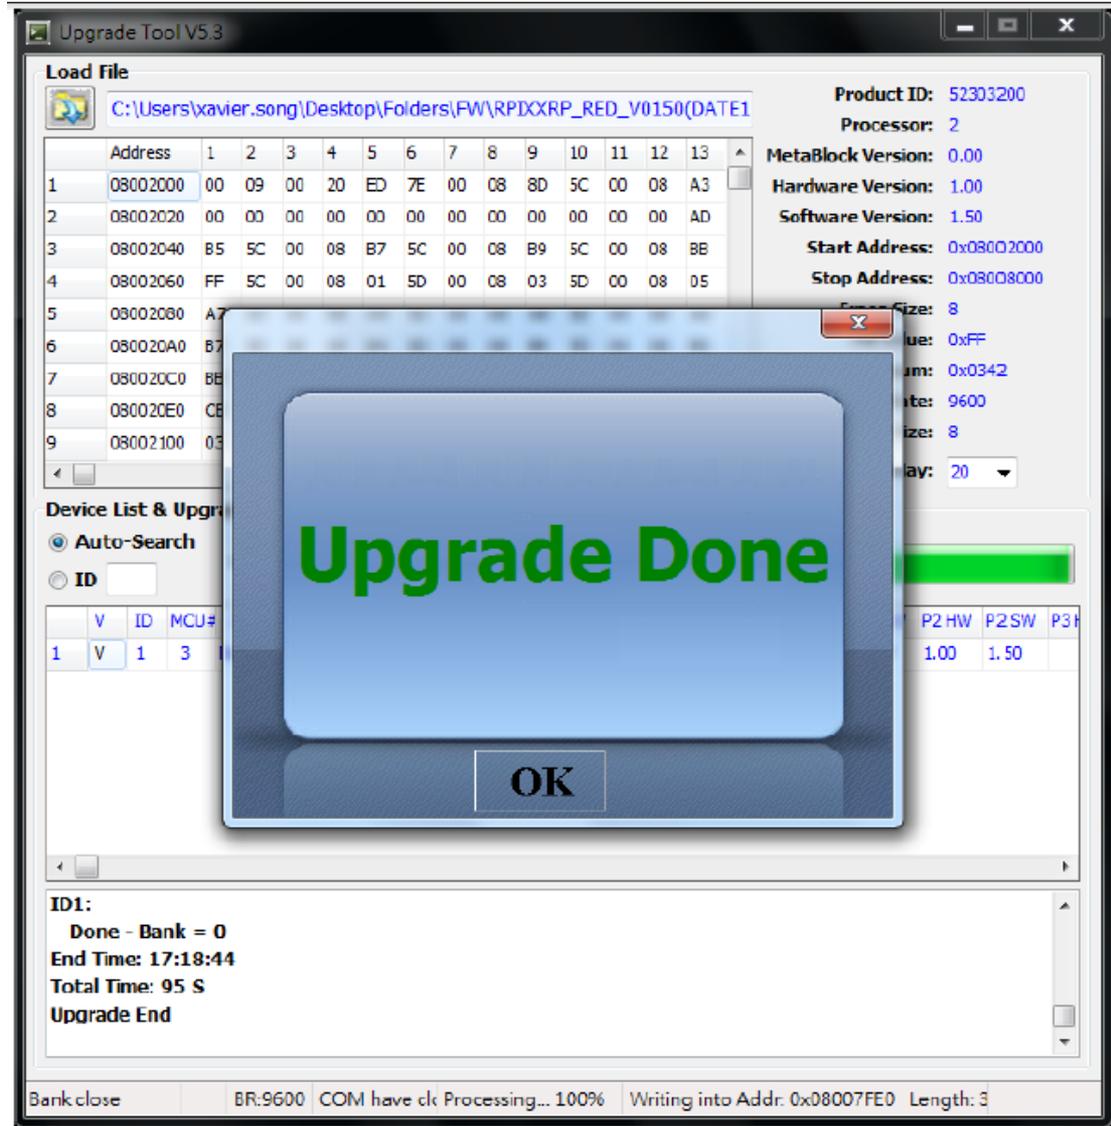
VII. When upgrade done appears, the upgrade for this processor is finished.

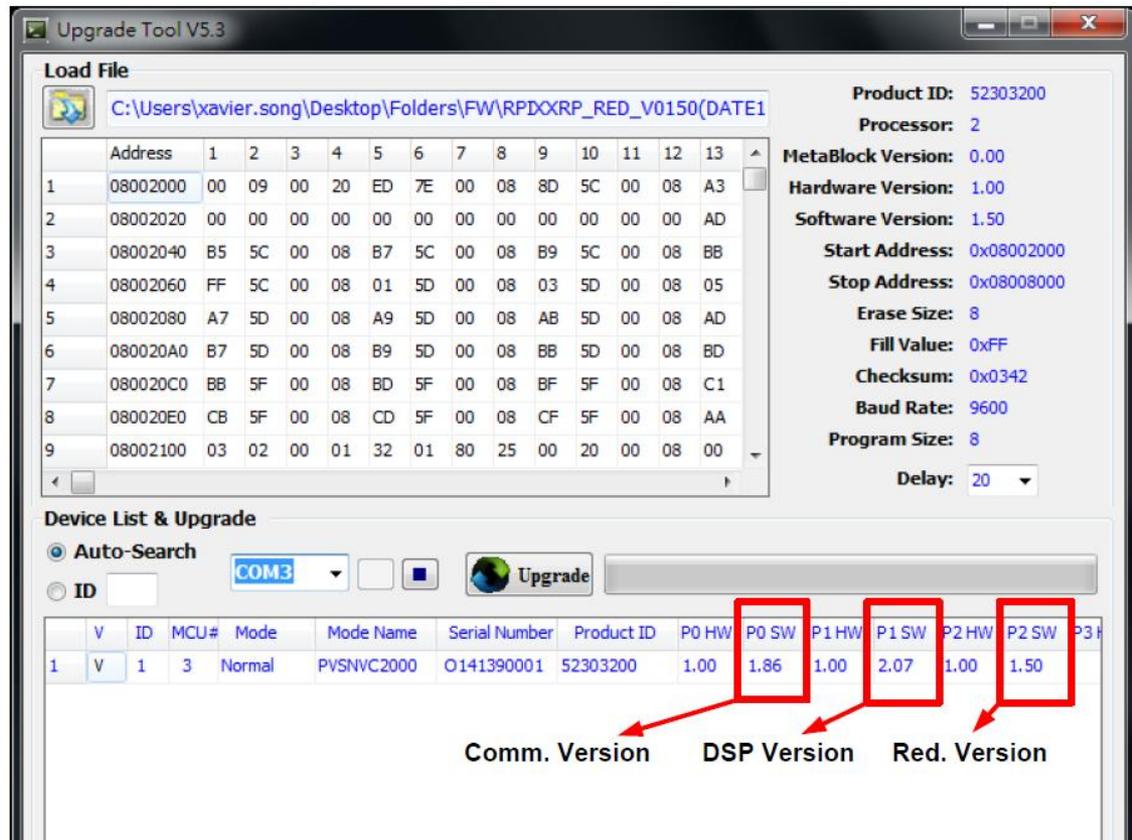
- X. Verify the following version numbers
 - Processor0 (Comm) - SW should be 1.96
 - Processor1 (DSP) – SW should be 2.10
 - Processor2 (RED) – SW should be 1.50

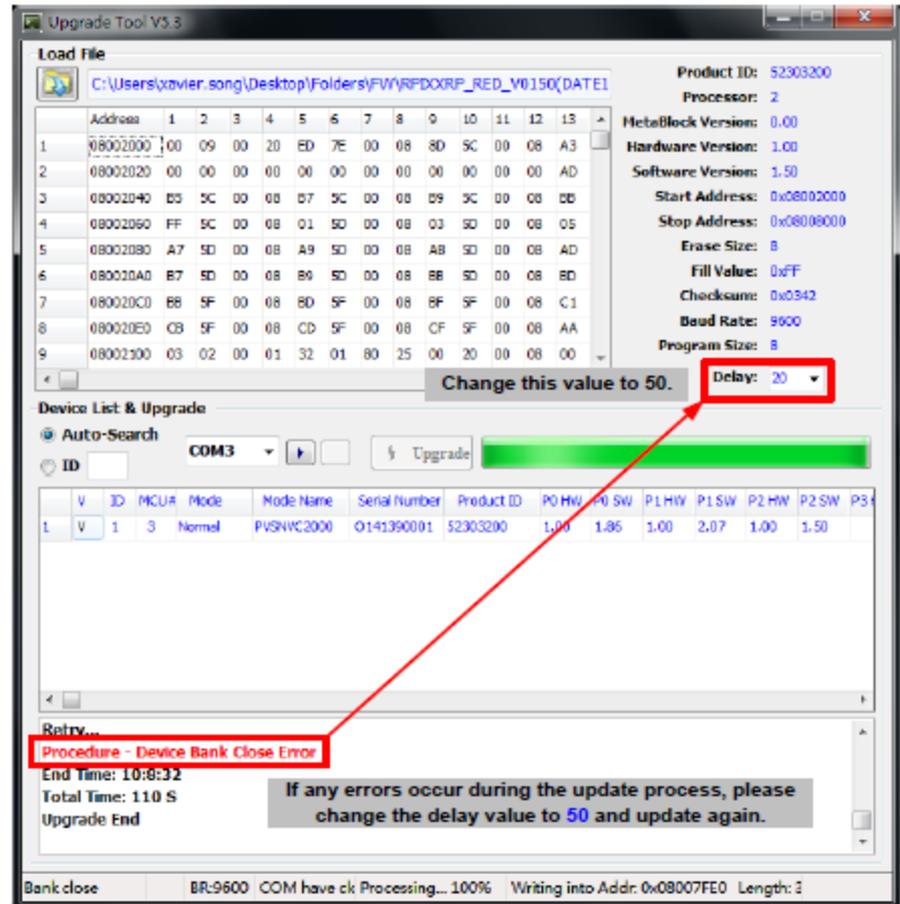
If your upgrade fails, you will see a green and red LED on the LCM flashing alternatively. It means the inverter is in Boot loader mode. Please adjust delay value to 50 and then upgrade and try again.
