Conext CL Firmware 2.6.4

Upgrade Procedure

February 2017

Rev 03

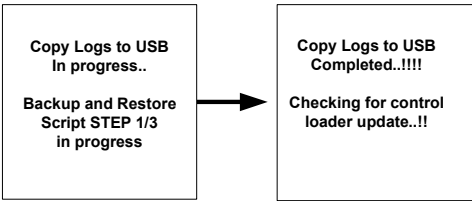
Figure 1-2 Copy Logs to USB completed screen

- 7. Inverter reboots, once the above process completed.
- 8. After successful boot up, inverter LCD display should show below message as shown in Figure 1-2 on page 1–5 and Grid LED and Fault LED should blink ON and OFF.

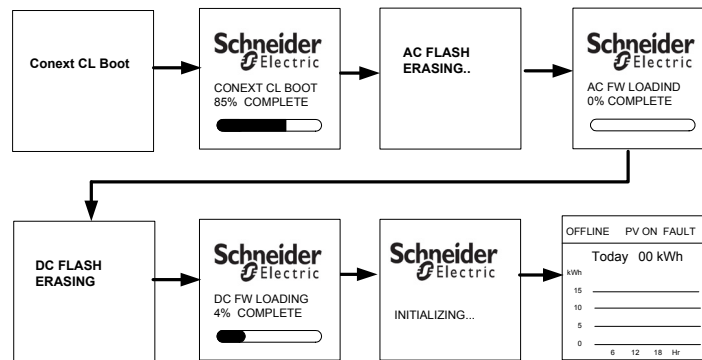
Figure 1-4 DUI screen

10. Once Control Boot loader files are copied successfully, inverter goes for reboot to upgrade new control processor boot loader. These status can be monitored on DUI as standard firmware upgrade sequence of DUI screens as shown in Figure 1-4 on page 1–6.

- s) The DUI displays ask for upgrade confirmation and "Press OK To Upgrade Firmware". Refer to Figure 1-4 on page 1-6 which shows upgrade process.

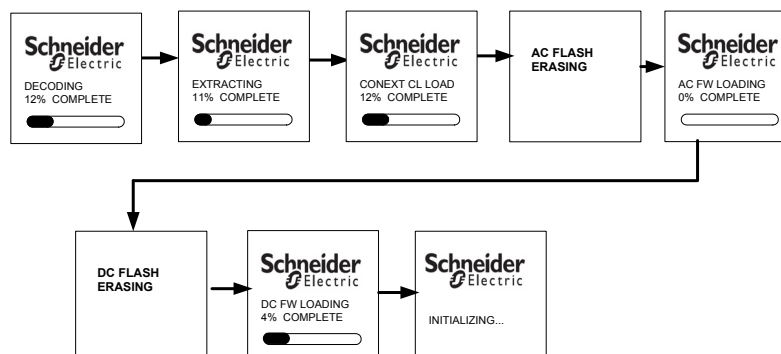
Figure 1-8 Firmware upgrade screen

14. Once above screen popped up, inverter goes for reboot and boots up with new Comm boot loader.
15. Once rebooted, firmware upgrade will continue as shown in Figure 1-8 on page 1-7.

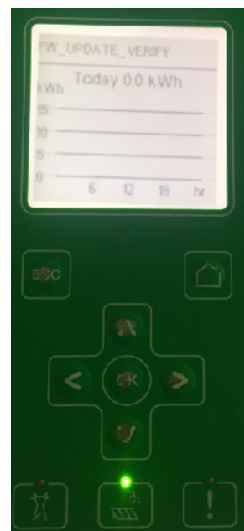
3. Please insert the USB drive which has the contents mentioned in step 2. Once the USB drive is inserted, the LCD display backlight will switch ON and OFF 5 times to indicate the start of the script execution.
4. After the USB drive is inserted, the Lux script starts executing, it gets all system information and it verifies the versions of these 5 components. During this verification process, the LCD display backlight will switch ON and OFF, the 3 LEDs (Grid, PV and Fault) will blink ON and OFF and the following screen will be displayed, until this process is completed.

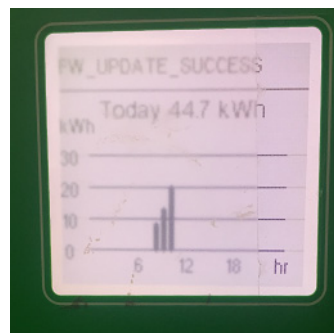
5. After the FW verification process is completed, if it is successful, the following screen will be displayed on the LCD and the Grid LED and PV LED will blink ON and OFF for 20 seconds.

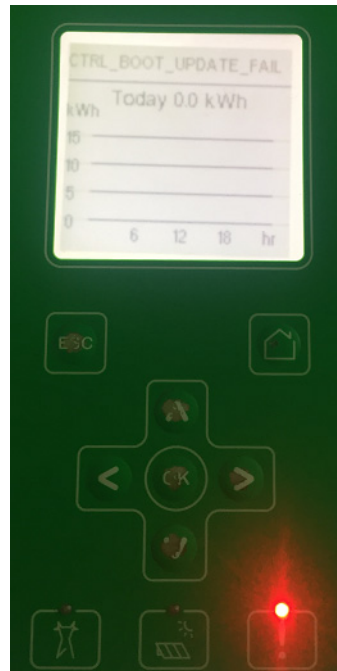
- a) If the Control Bootloader is not updated, the following screen will be displayed.

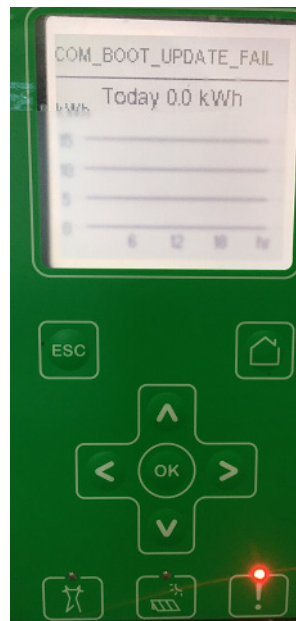
- b) If the COMM Bootloader is not updated, the following screen will be displayed.

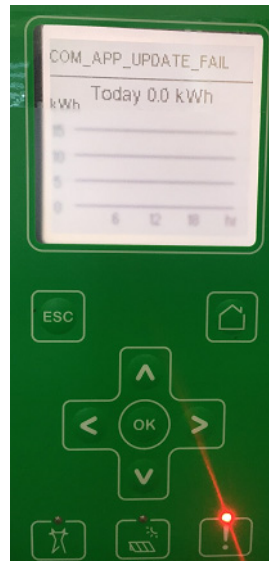
- c) If the COMM Application is not updated, the following screen will be displayed.

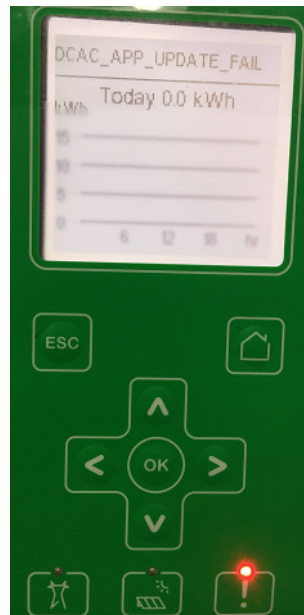
- d) If the DCAC Application is not updated, the following screen will be displayed.

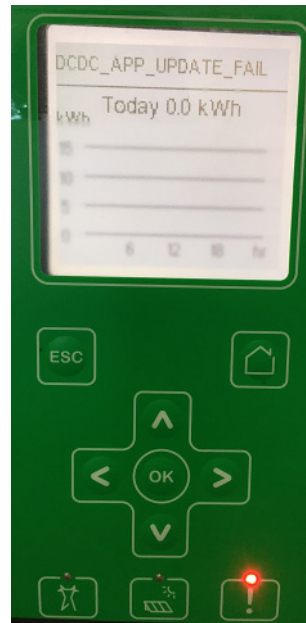
- e) If the DCDC Application is not updated, the following screen will be displayed.

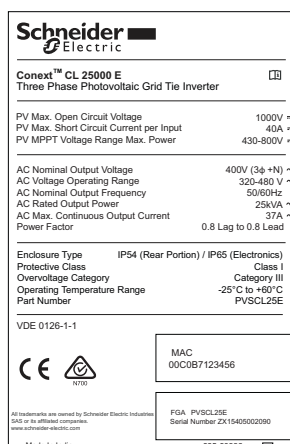
Figure 1-14 Inverter label

- k) Select the DUI Config as shown in Figure 1-13 on page 1–15.
- l) Note down the Serial number, MAC and FGA details from the inverter label as shown in Figure 1-14 on page 1–16.

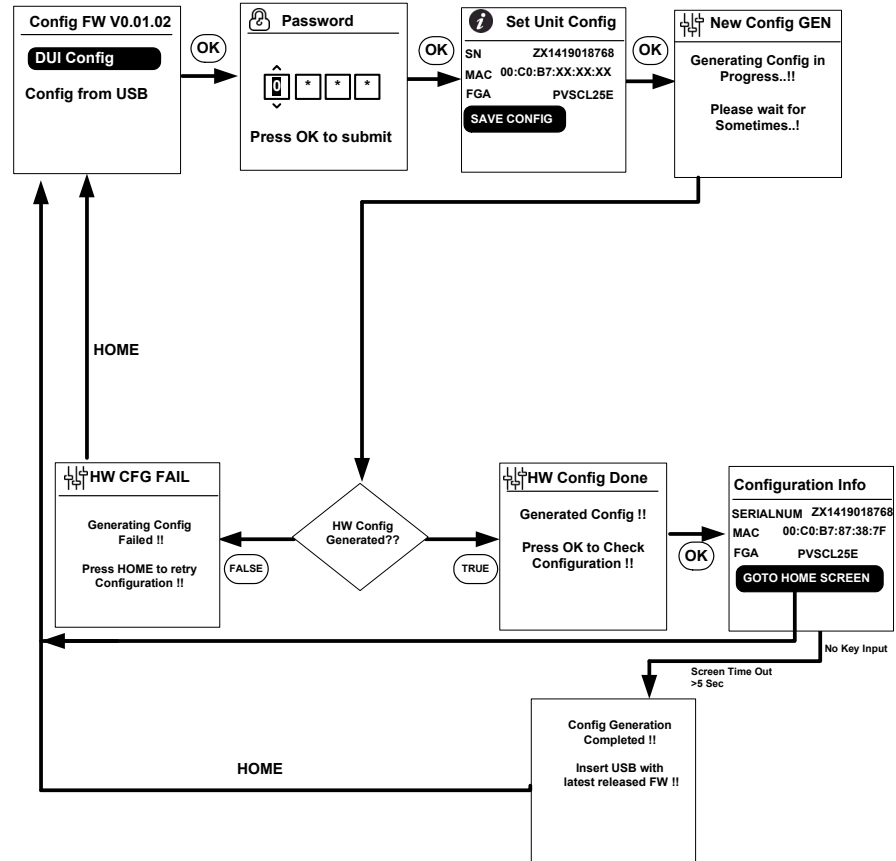
Figure 1-15 Configuration Info screen

- n) Once hardware configuration is generated user can check the same details on **Configuration Info** screen as shown in Figure 1-15 on page 1-17.
- o) Configuration Info screen is displayed for some time. User can check the details entered are correct or not. If any data needs a correction select "GOTO HOME SCREEN" and press OK to go to Home screen and enter data appropriately. Otherwise wait for screen to time out.

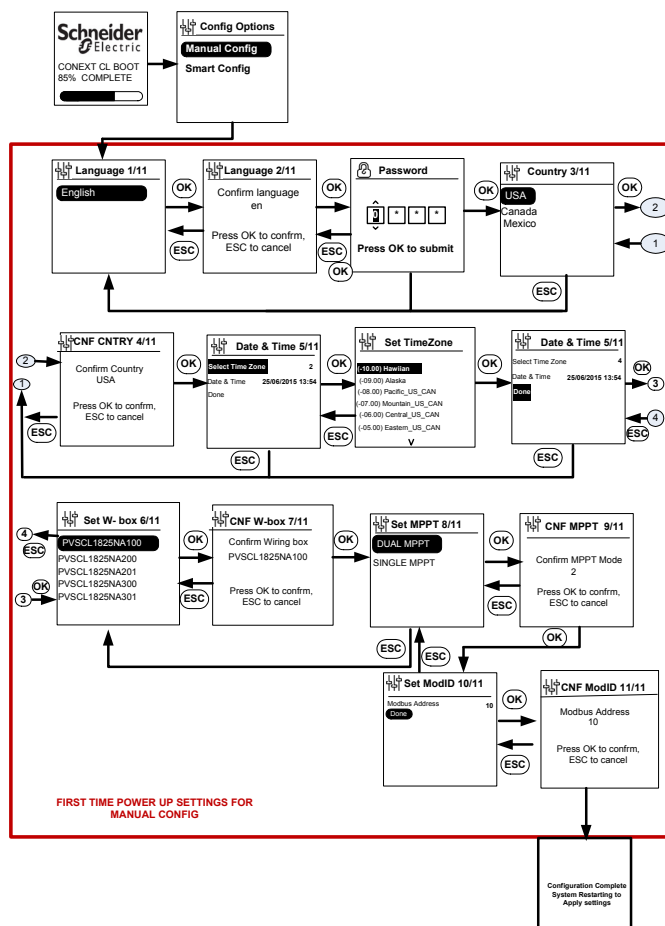
Figure 1-16 Configuration Info screen

- t) Once firmware is upgraded successfully the inverter DUI shows the first time configuration screen. User needs to configure the inverter appropriately as shown in Figure 1-16 on page 1-18. Once configured, the inverter will reboot and be ready for operation.
